BUILDING-STRUCTURE INVENTORY FORM

1. BUILDING NAME(S): _____
2. COUNTY: Monroe TOWN: Greece
3. STREET LOCATION: 505 Elmgrove Road
4. OWNERSHIP: a. public [] b. private [X]
5. PRESENT OWNER: Christopher & Elaine Maenza ADDRESS: 25 Willowen Drive
Rochester, NY 14609
6. USE: Original: residence Present: residence/kitchen
contracting business in rear.
7. ACCESSIBILITY TO PUBLIC: Exterior visible from public road: Yes[X] No[]
Interior accessible: Explain private residence

Town of Greece Historic Sites Survey
Monroe County, New York
505 Elmgrove Road
page 5

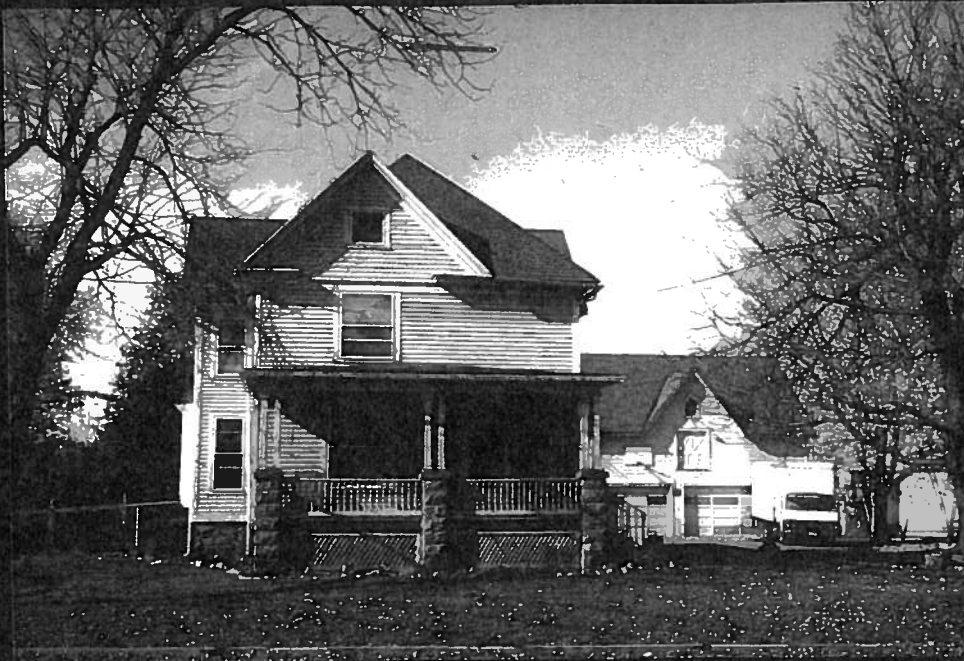
18. Two and one-half story, frame house featuring a hipped roof with lower cross gables. Beneath the eaves of the roof is a narrow, frieze band. The house is sided with wood clapboards and sits atop a stone ashlar foundation. Fenestration is regular and repetitive with one-over-one, double-hung, wood sash. The front, east, elevation has a full-width, hipped roof, front porch with a spindled balustrade, and rock-faced concrete block piers each with square columns above. The front door, in the north end of the facade, has recessed wood panels in the lower part with glazing in the upper half. The gable ends on the front and side elevations have cornice returns and ornamental fishscale shingles.

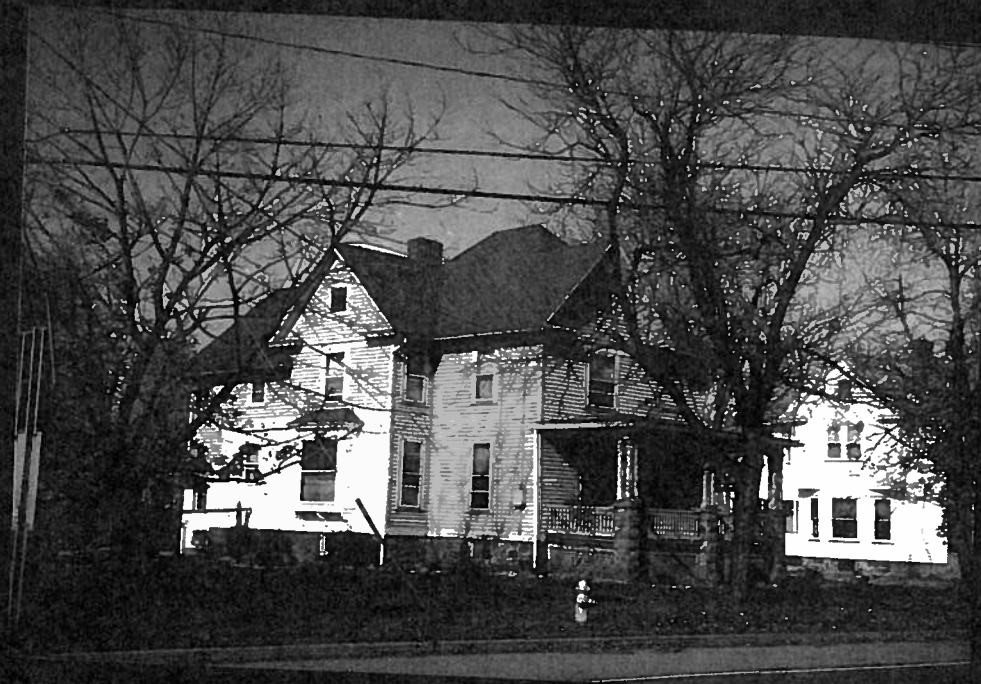
The north elevation features a cross-gabled bay. The east end of this bay has a cutaway corner. The one-story porch at the west end of the north elevation features turned posts and a spindled balustrade.

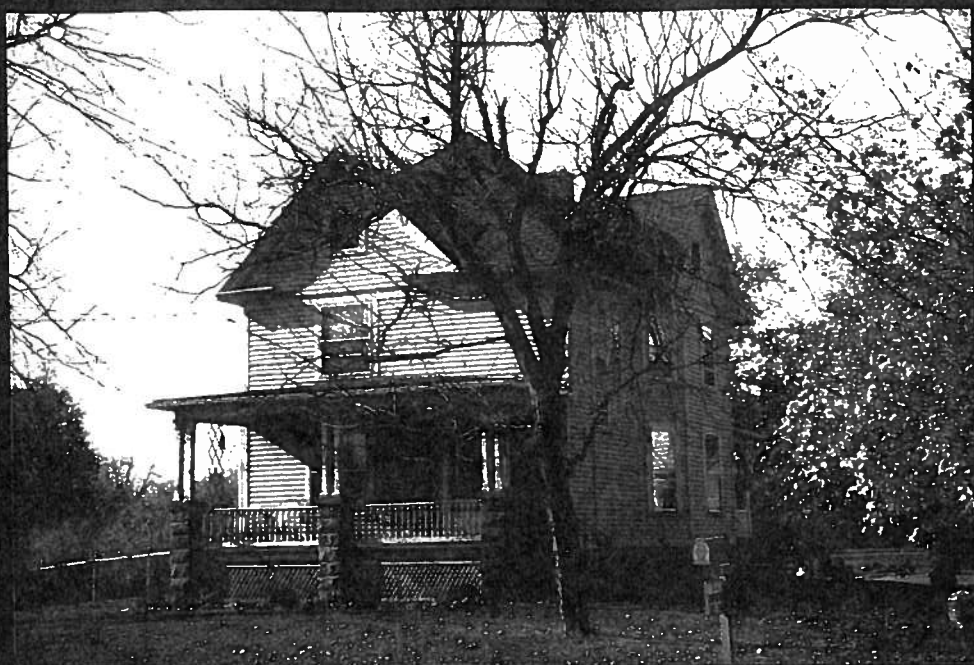
A bay window with brackets is located in the center of the projecting cross-gabled bay on the south elevation. A side entrance at the west end of this elevation features a bracketed hood.

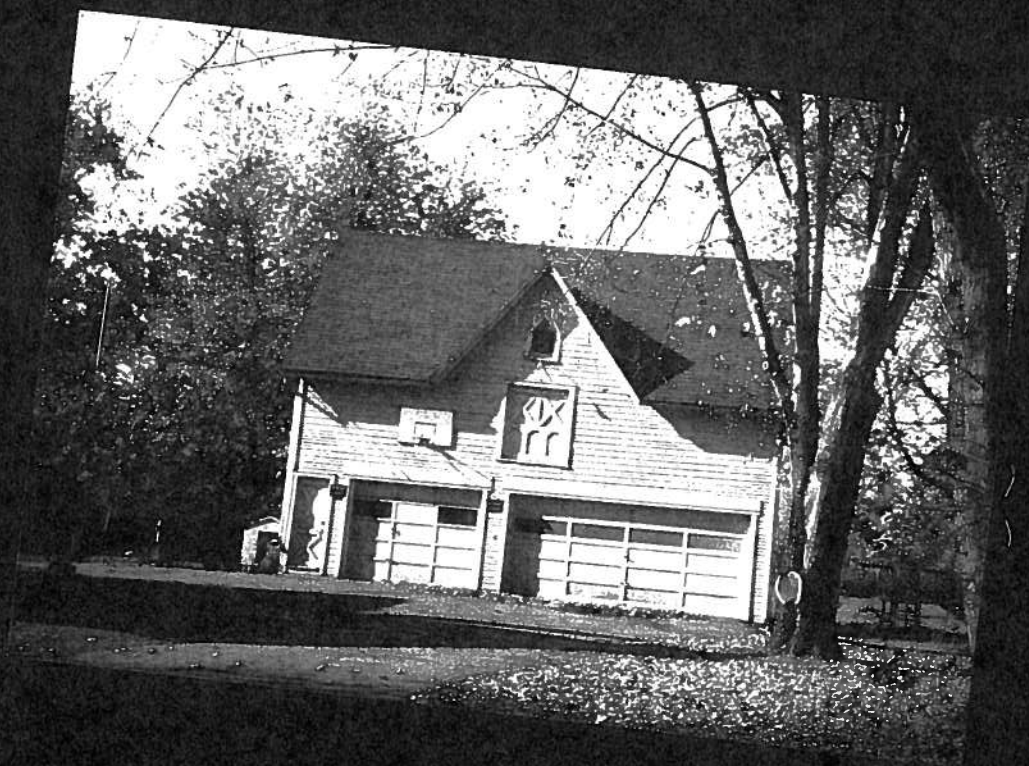
The contributing carriage barn is a side-gabled frame structure with a centered cross gable in the front. The barn is clad with novelty siding. A triangular arched (pointed) window can be found in the cross gable at the front facade. The original loft door on the second floor is intact. Two modern overhead garage doors have been added at the front elevation.
